Our Ref.: PSE/TQ/2021/41778 Date: 08 October 2021 engineering.support.lhd@leonardocompany.com From: LH Service Engineering **Bristow Helicopters** TO: 1/7 Page: Mr. David Ireland Attn: david.ireland@bristowgroup.com SUBJECT: AW189 S/N 92004 (TT 1880.01 FH): AMPI task 63-28 completion postponement

Subject: Deviation from 8Y MGB inspections

AW189 SN:92004 G-MCGR AF Hrs 1880:02 MGB PN:8G6320A00132 SN:V25-1 Hrs 1880:02

Main Gear box group scheduled inspections

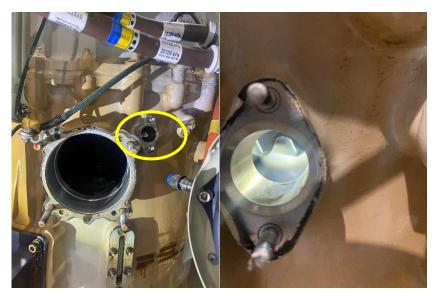
Please be advised that due to the positioning of the speed sensor housing only the lower side of the collector gear teeth can be inspected, as such there is no accessibility to any of the areas directed to by step 2.3. The speed sensor is physically below the collector gear installation. See below.

It is possible to postpone until November 22, 2021, the collector gear upper surface inspection recalled in AMPI Task 63-28, and in step 7 of AMP DM 89-A-63-20-00-00A-281A-A Main gearbox group - Scheduled inspections, provided that the remaining steps of AMP DM 89-A-63-20-00-00A-281A-A are successfully performed, except for deviations reported in Annex B.

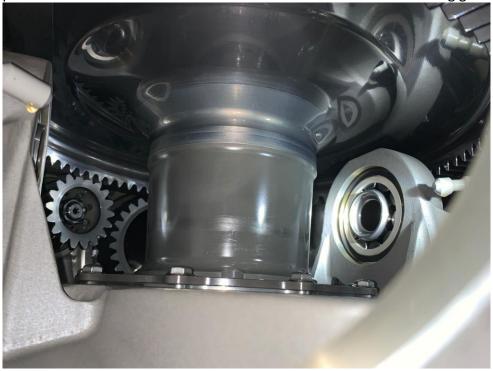
We have noticed that the collector gear bearing can be inspected by using a boroscope through the center of the mast and Tail take off bearing is accessible through the ECS cover/installation point. See below. Please note that care should be taken when moving gears with boroscope in use.
